Synchronizing multiple E1430A modules

2008-09-03 D. Teuchert

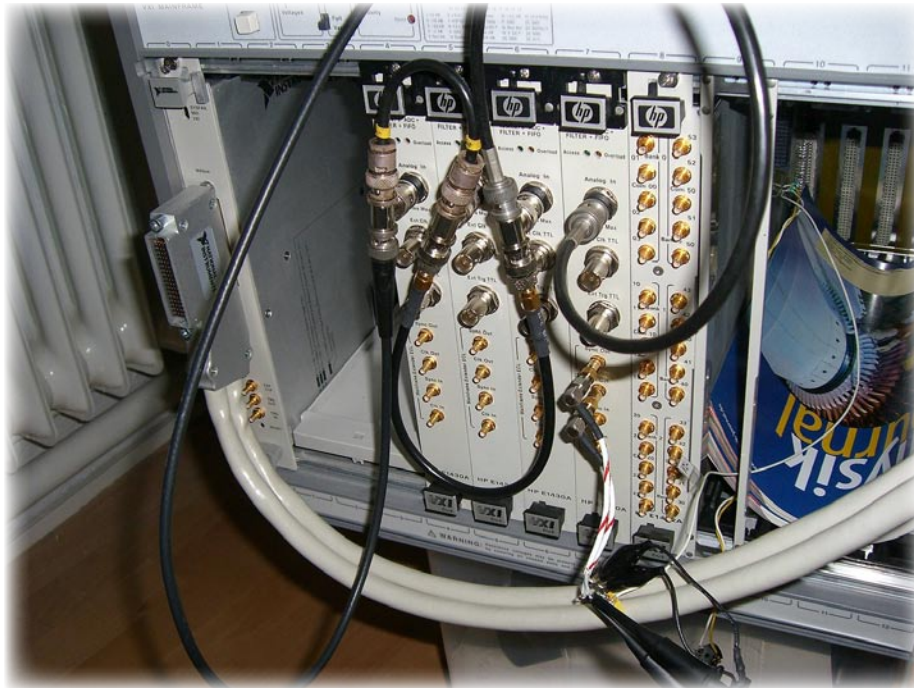
VXI crate with extender and group of digitizers. An empty and half open E1407C is used as a breakout box. Empty slots are ventilation blocked.

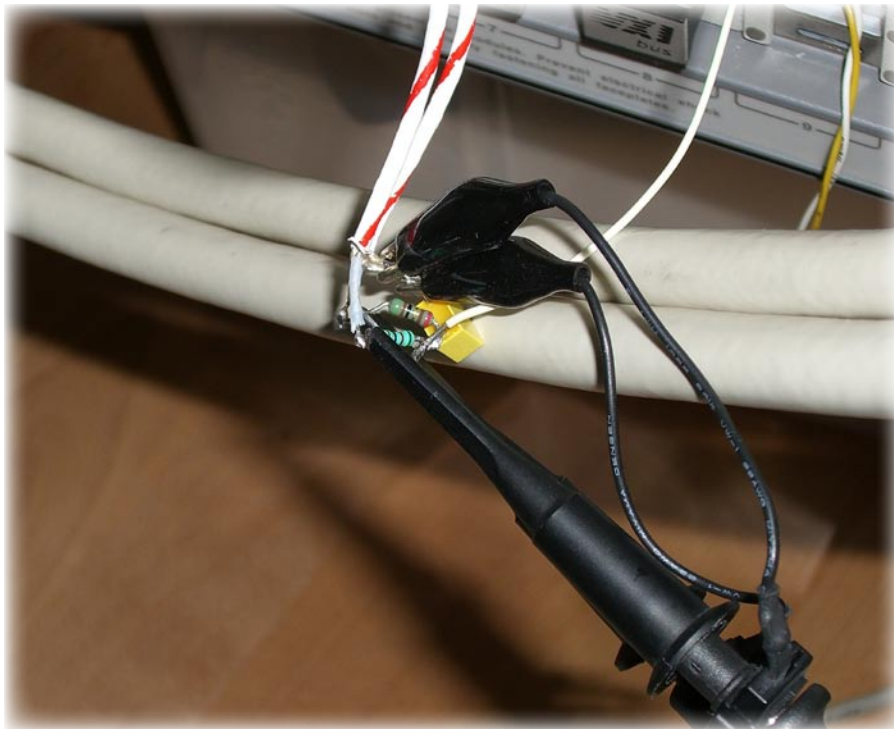
The two ECL lines connected to $-2 V_{CC}$ via 50 Ohm pulldowns and to the scope probes.

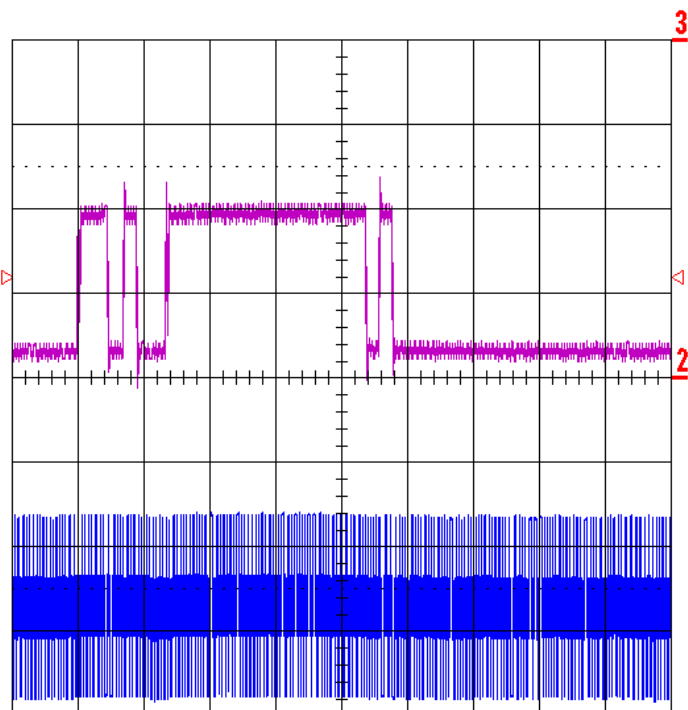
Sync and clock during `e1430_reset_dsp()`.

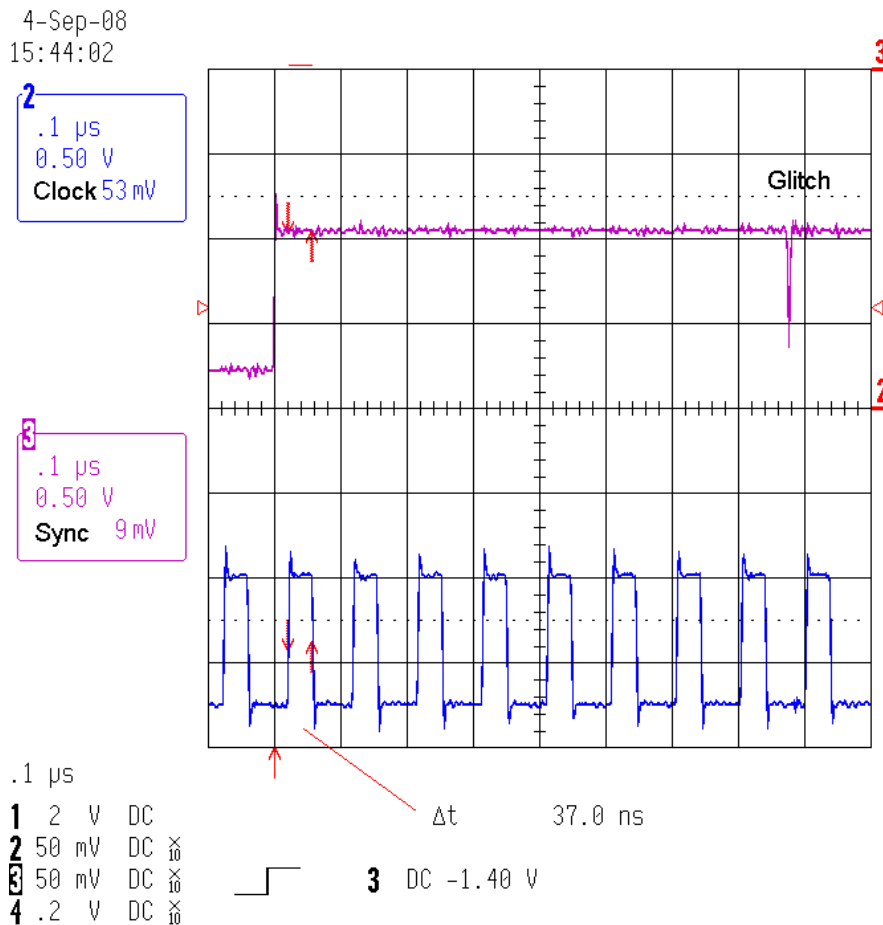
The signals looked clean, except that during synchronization there are 5 nsec low glitches in the pulled sync signal, always precisely 0.75 μ sec after sync line pulled by master. Anyway, these glitches don't matter, since the sync signal is sampled at the rising edge of the clock signal. The clock signal appears as a short positive pulse (asymmetric).

Sync and clock detail with glitch mentioned in text.
